FINAL REPORT OF SPECIFIC PURPOSE LIDAR SURVEY

LiDAR, Breaklines and Contours for Suwannee River Water Management District, Florida

**Add-On Agreement to
State of Florida
Division of Emergency Management
Contract 07-HS-34-14-00-22-469**

January 19, 2009

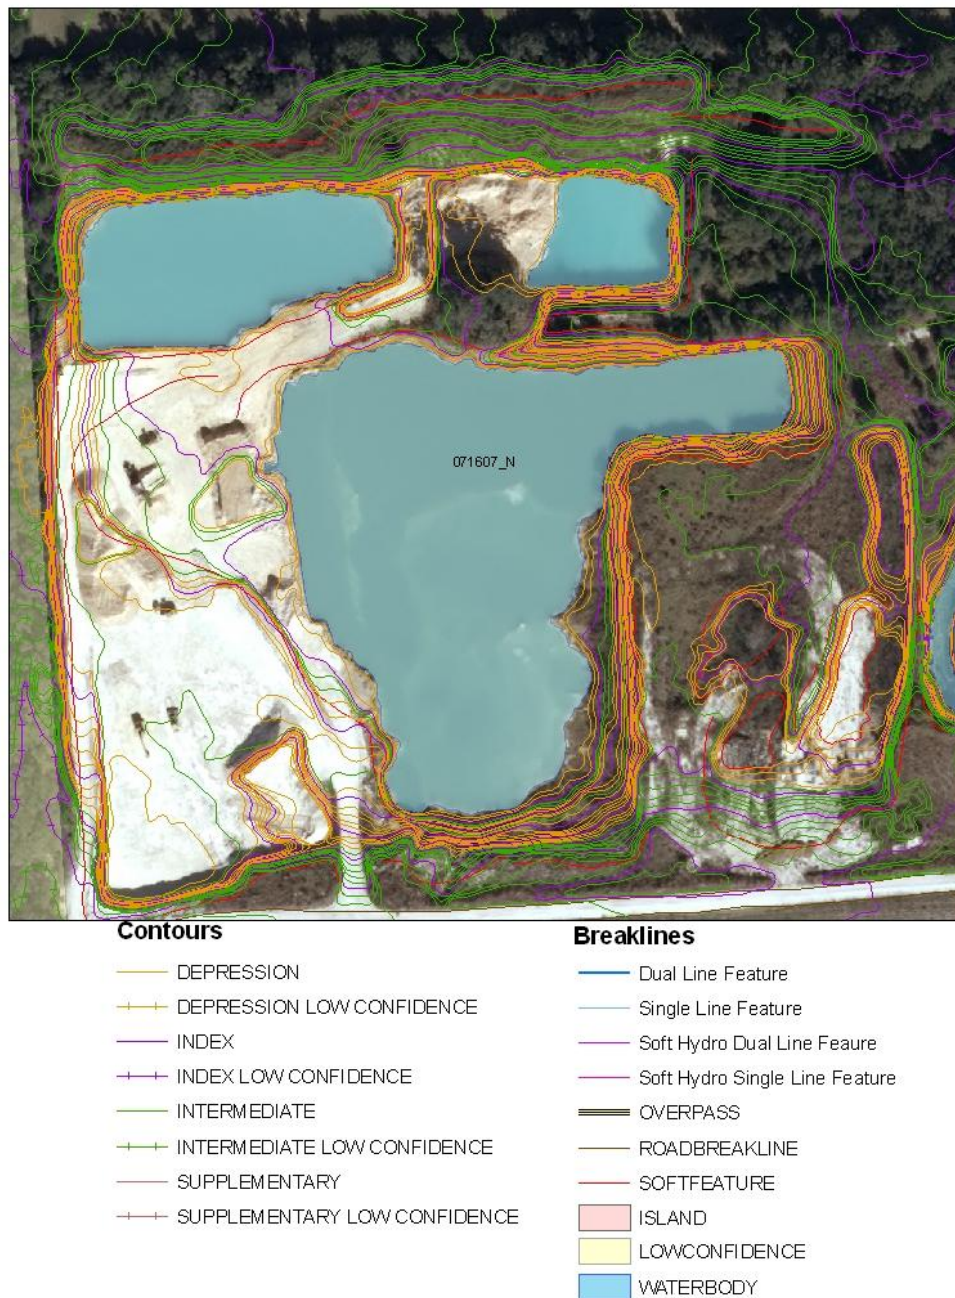
Closed water body features with an area of one-half acre or greater are correctly captured as two-dimensional closed polygons with a constant elevation that reflects the best estimate of the water elevation at the time of data capture. “Donuts” exist where there are islands within a closed water body feature. Figure 2 shows example breaklines and contours of closed water body features.

Figure 2. Example closed water body feature breaklines and contours from tile #71607
